Asbestos Register

New Town Primary School, School Terrace, Reading

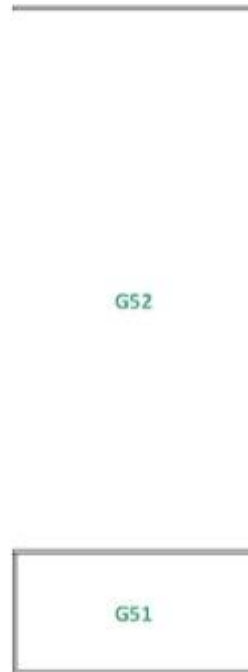
Room Ground/Basement (Nursery Block)

G01 = Room Number Asbestos Containing Materials (ACMs)

— Positive Sample Location
